GASOLINE CONTAMINATION OF A PRIVATE WELL SUPPLY. COMMUNITY OF
TAUNTON.

BY: ONTARIO. MINISTRY OF ENVIRONMENT.

Municipality..... Community of Taunton..... Date of Inspection.....
Re:..... Gasoline Contamination of a Private Well Supply.....
Field Inspection by D. Smith, R. Hodgins..... Report by D. Smith, C.E.T.

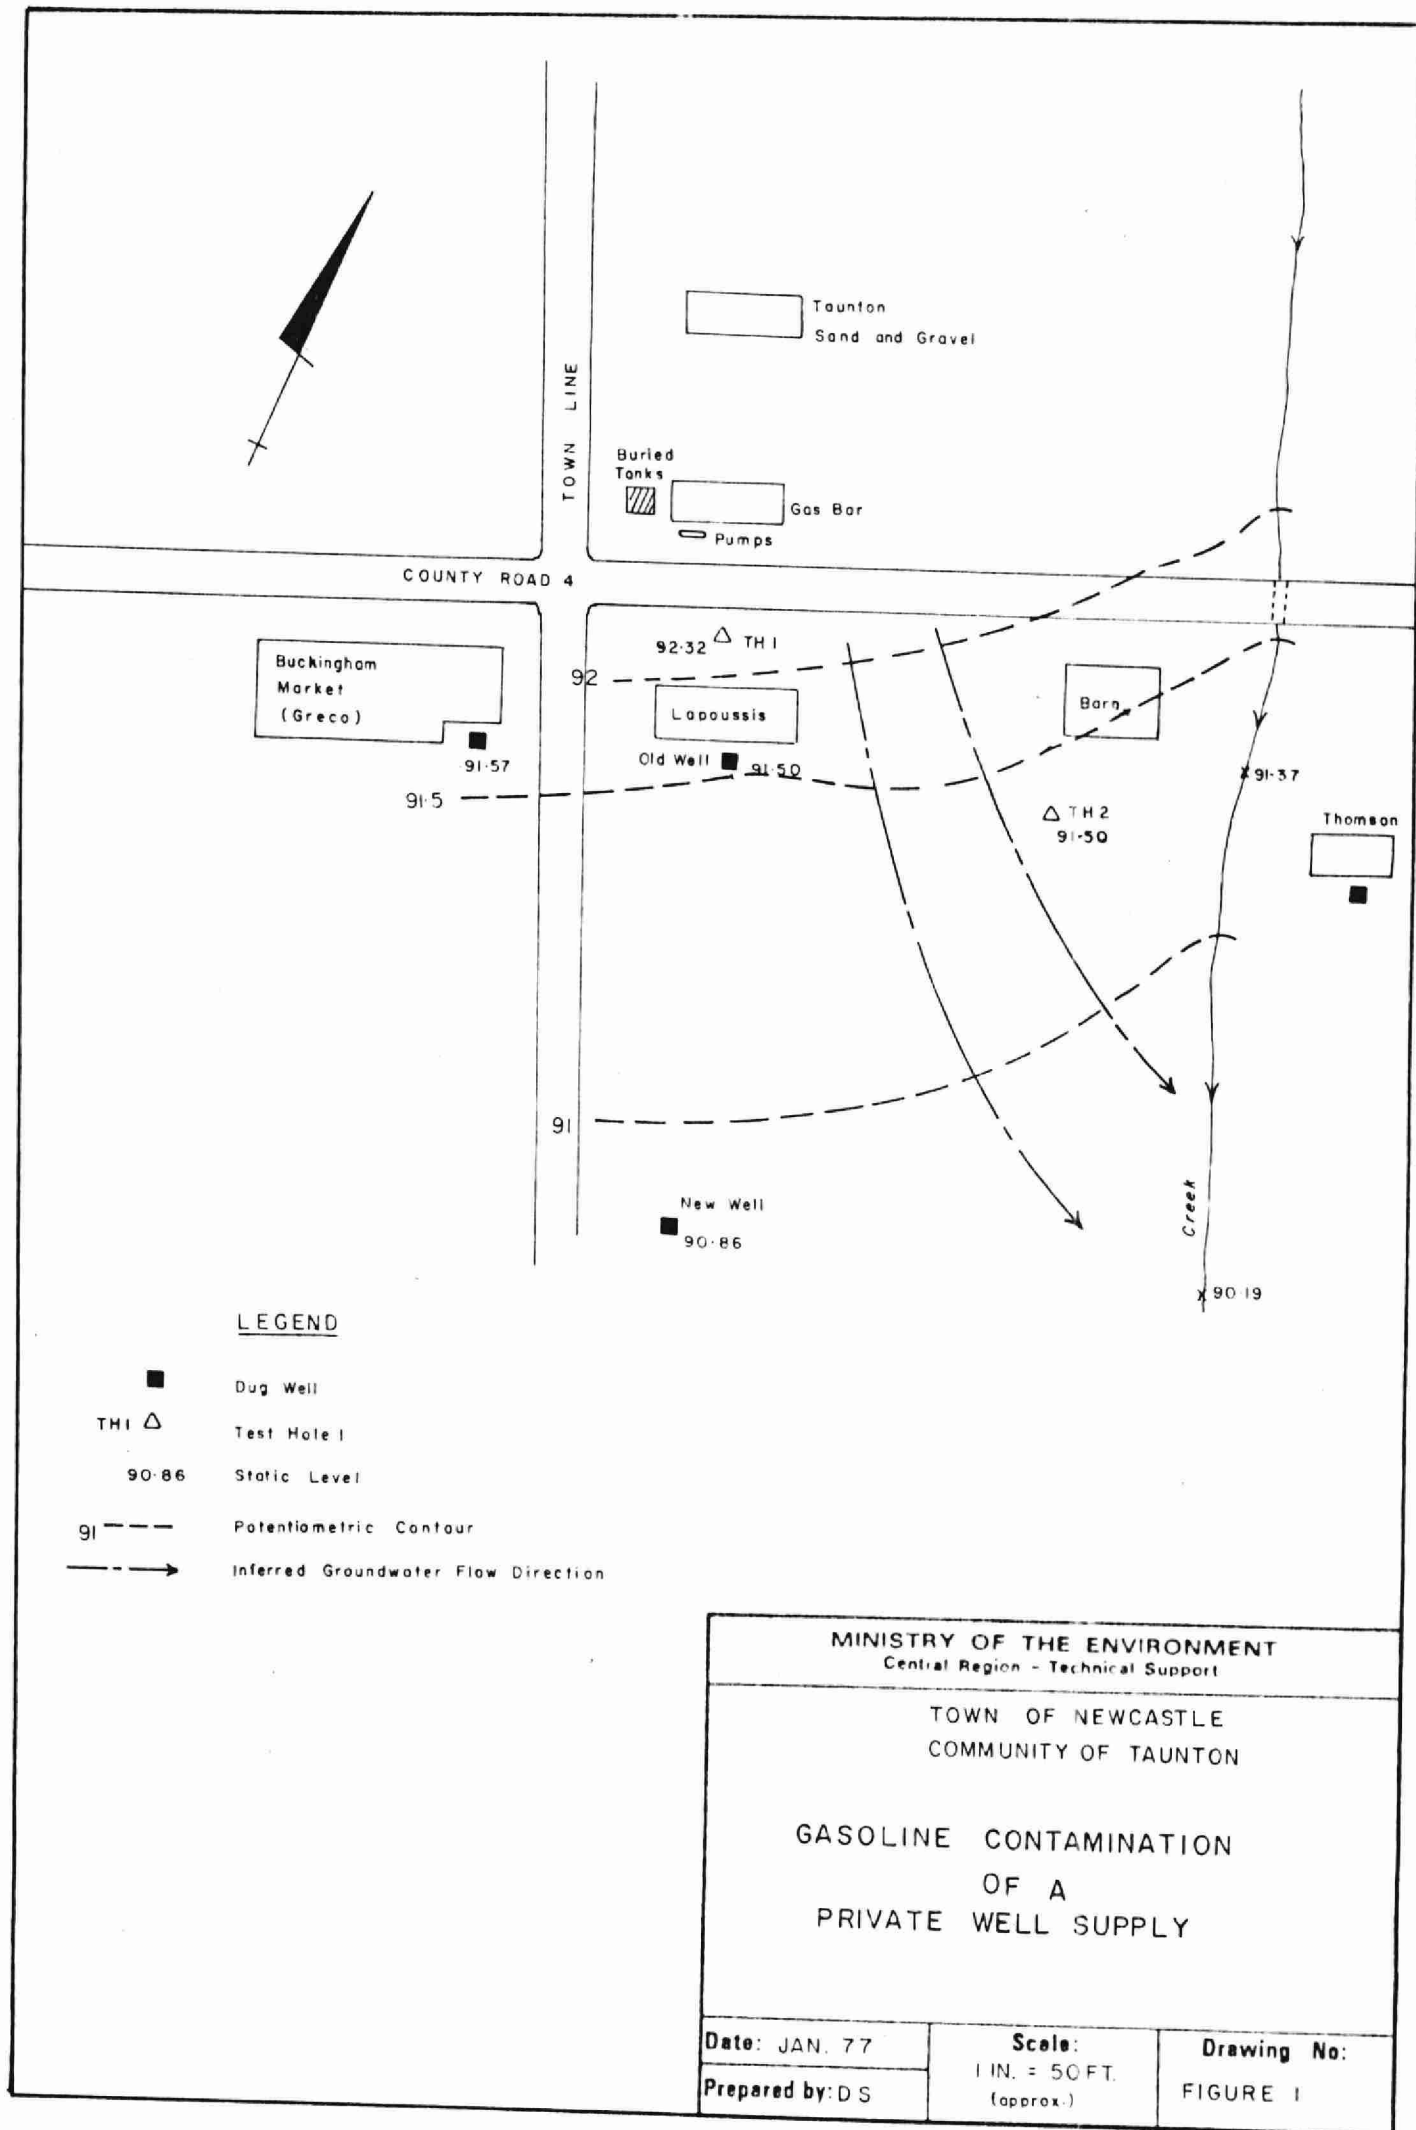
At the time of the levelling survey the groundwater flow direction was found to be as shown in Figure 1. It also appears from the topography and levelling survey that a groundwater divide exists in this area which roughly corresponds to the ridge.
